Blister, Pinholing & Bughole Troubleshooting

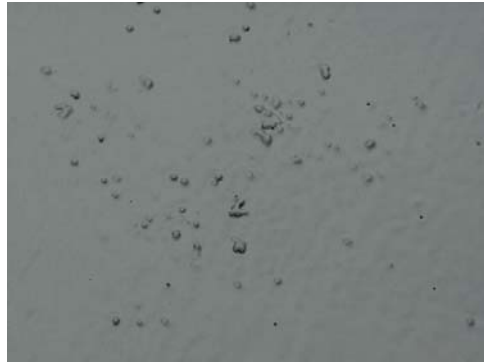
Figure 3: Shadowing Effect

Another phenomenon, sometimes confused with pinholing, is voids in the coating system due to a shadowing affect. This occurs when a fast set coating system is applied to a substrate that may be dirty or contain overspray. As you are spraying in one direction, the fast set coating builds on the contamination and does not completely flow around it. This dirt or overspray particles actually create a shadow for additional spray over the surface, creating a small bare spot in and around the shaded side of the substrate contaminant. While this may be a common occurrence, it should not be overlooked, as this is a point for coating failure, especially in immersion applications. An illustration of this can be seen as follows (Figure 3):

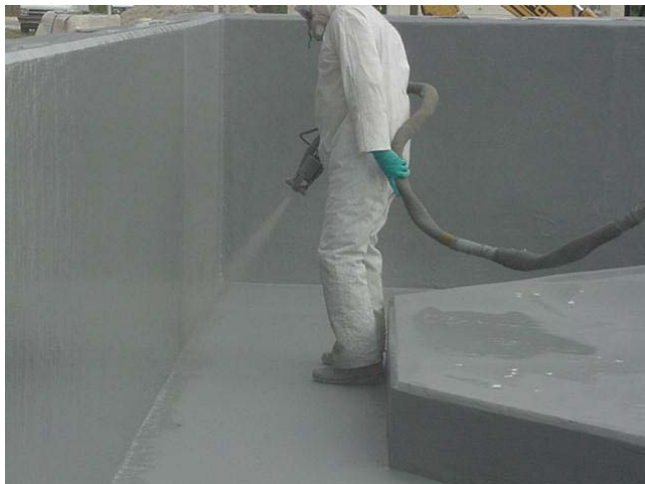
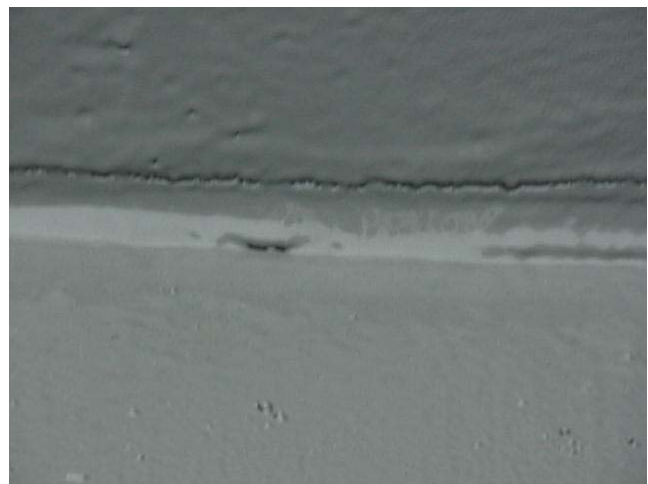
Figure 4: Improper spray technique and resulting “shadows” / “cracks”

Shadows can also be present when the improper spray technique is used. This would be were the spray gun is not being held perpendicular to the substrate during the spray work. The “shadows” will appear as a form of pinhole or “crack” in the applied polyurea. This is especially true at floor / wall intersections. The following figure shows improper spray technique and the result on the substrate.

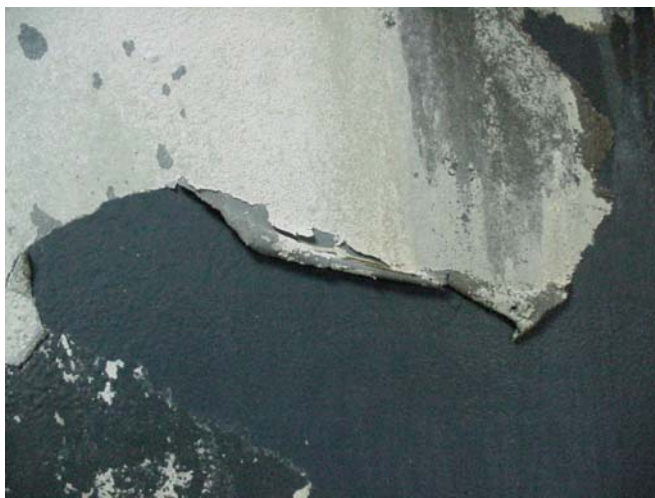
Figure 8: delamination of lining

Results of not pre-filing bugholes and / or pinholes in lining system in waste-water application.

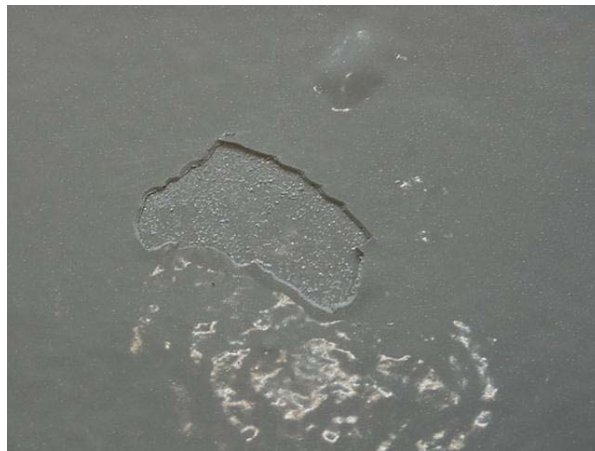
Figure 10: ISO Blister

| <u>Back Side of Blister</u> | <u>Probable Cause</u> | <u>Solution</u> |
|---|---|---|
| Rough / Hairy | Moisture reaction Off ratio / iso rich | Dry substrate / check for Moisture drips or dew point Confirm dry compressor air Check operating temperature Check operating pressures / equal Confirm proper Module/PCD Clean module / screens |
