The Challenges of Field Application of Polyurea; Interior and Geotextile Applications

Dudley J Primeaux II, PCS
Lee Bower

2008 PDA Annual Conference
February 12 – 15, 2008
Hyatt Regency - Atlanta, Georgia

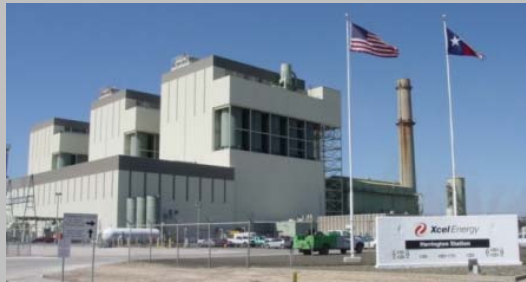
Site Access

- **Project #1**

- 11th Floor of coal fire power plant, 3 buildings
- No freight elevator, equipment placements
- Most of plant in operation

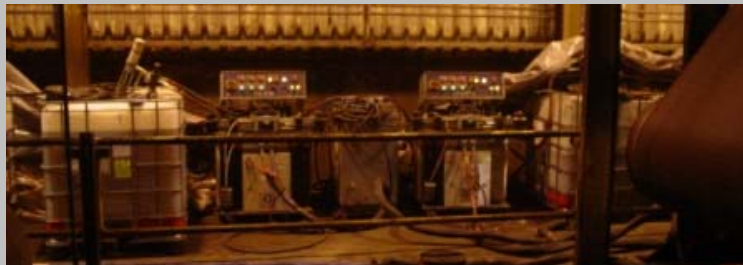
Site Access

- **Project #1**

- 11th Floor of coal fire power plant, 3 buildings
- No freight elevator, equipment placements
- 2 spray units used, relocate in each building
- Material supplied in totes / IBC's

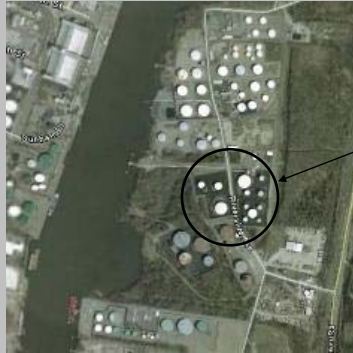
- “wide open” area

Application location,
~ 410,000 ft² / 38,000 m²

- “wide open” area
- Active fuel storage area
- 2 trailer units used, staged
- Material supplied in drums, 4 truck loads
- Rolls of geotextile to move / place

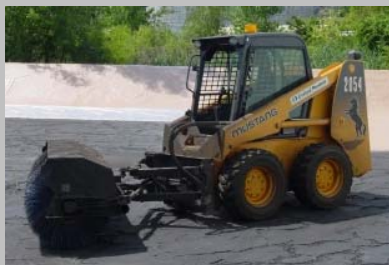
Surface Preparation

- **Polyurea / Geotextile Lining**

- SSPC-SP 3, Power Tool Cleaning
- “Bobcat” fitted with power-roller brush
- Removed loose gravel, knocked down asphalt heave
- Geotextile covered the asphalt substrate

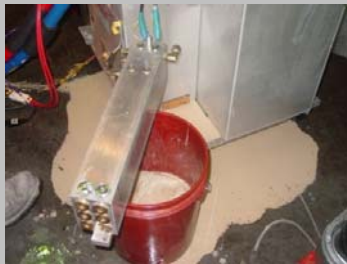
Equipment Issues

- **Project #1**

- Blown resin heater plugs, factory equipment issue
- Off-ratio application, clean-up
- Proper training prevented application problems

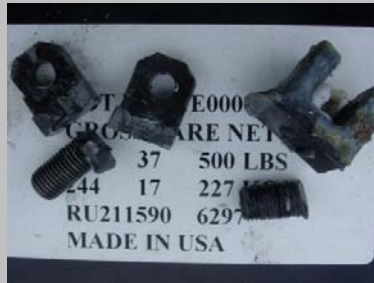
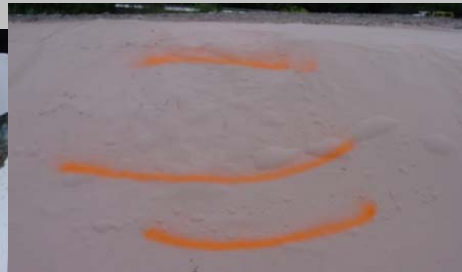
Equipment Issues

- **Project #2**

- Broken Clevis', proportioner
- Off-ratio application of material, re-spray / repair
- Prepared, had replacement parts!

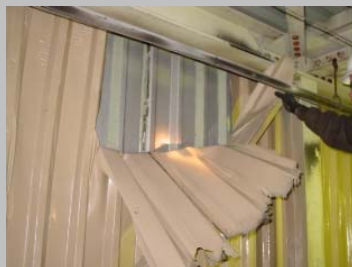
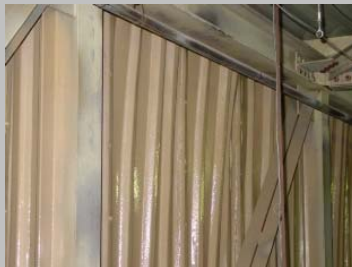
Myth of Polyurea & Moisture

- **Project #1**

- Complete delamination of wall area
- Substrate temperature **not** above dew point
- Thin sheet of ice present (invisible)
- Remove, prep & re-spray

- What is the required substrate temperature to dew point temperature difference?
- Substrate **MUST** be 5°F (3°C) above, and rising, the dew point temperature!
- Moisture and / or ice on substrate will inhibit bonding of polyurea

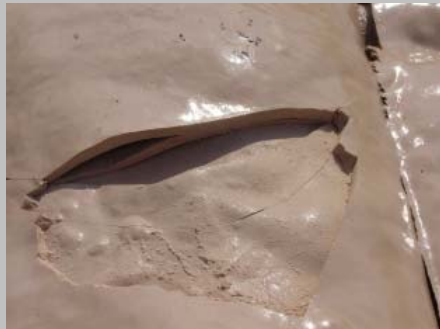
Myth of Polyurea & Moisture

- **Project #2**

- Foaming of applied polyurea
- Water in Resin drums, loose bungs & rain
- Infamous “purple” liquid
- Cut-out and repair

- Eventhough a **Polyurea**, if you put / get water in the system, it may react and cause issues.....

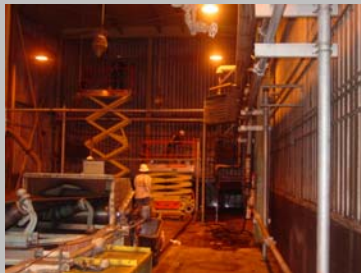
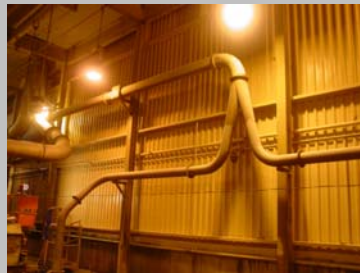
Project Completion

- **Project #1**
 - Completed in 26 days, 7 days ahead of schedule!
 - Used various high output and low output spray guns
 - Most time spent moving equipment

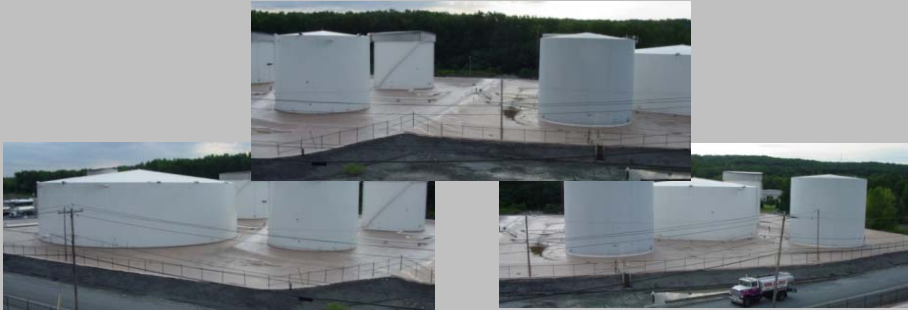
Project Completion

- **Project #2**

- Completed in 47 days, on schedule!
- Used single type configured spray gun
