Application Profile

- Project:** Cargill Agriculture, Elm Creek Farm Service Center
Manitoba, CANADA
- Polyurea Applicator:** EMW, Saltcoats, Saskatchewan, CANADA
Project Monitoring by Primeaux Associates LLC
- Polyurea System Applied:** PCS 350, JAG & Associates, Winnipeg, Manitoba, CANADA
- Substrate / Area:** Concrete Roof, approximately 10,000 ft²
- Date:** November, 2005

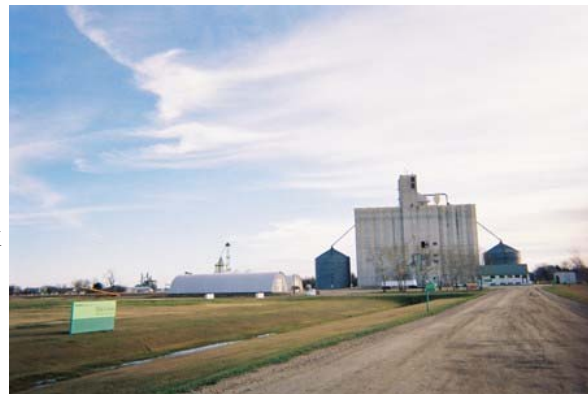
The Cargill facility is primarily a large grain elevator for seed and fertilizer. Constructed of concrete, the roof area has cracked and leaks, causing spoilage of the grain. Tar / asphalt has been used over the years, but continues to crack and require repairs. The polyurea technology was chosen due to the high elongation, toughness and ability to apply in the cooler weather.

Prior to installation, the old tar / asphalt had to be removed. This was done using a pressure wash system. The cleaned concrete roof was then primed using an epoxy based, low temperature primer system, followed by installation of a nominal minimum average 60—80 mils (1.5—2.0 mm) of the PCS 350 aromatic spray polyurea system. This system has an elongation of 400%, easily handling any movement that would occur in the structure.

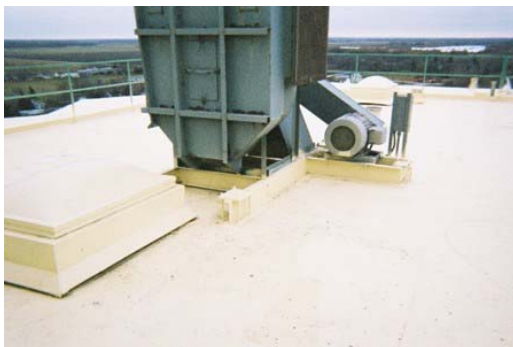
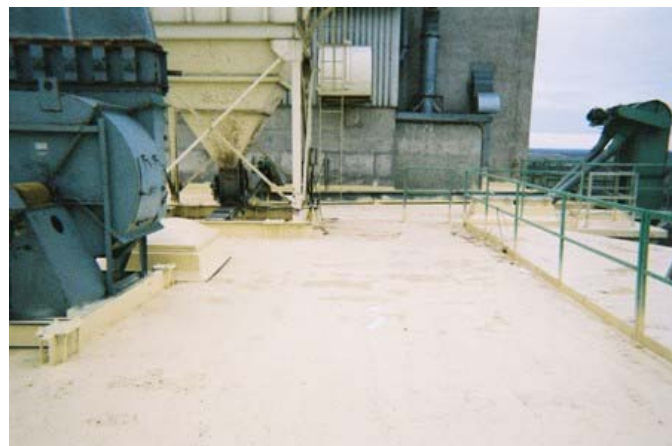
Since this was November in CANADA, there were several days where the rain, sleet and cool weather called for application interruptions. The fast / complete cure of the PCS 350 polyurea system was unaffected by these conditions. Application was completed in less than one week. There have been no leaks since installation work was completed.
